SECTION 32 PROGRAM
STREAMBANK EROSION CONTROL,
EVALUATION AND DEMONSTRATION
WORK UNIT 2-EVALUATION OF EXISTING
BANK PROTECTION

FIELD INSPECTION OF MORAMEAL REVETMENT
ON THE RED RIVER

Malcolm P. Keown, E. A. Dardeau, Jr.

September 1979
Inspection Report 7

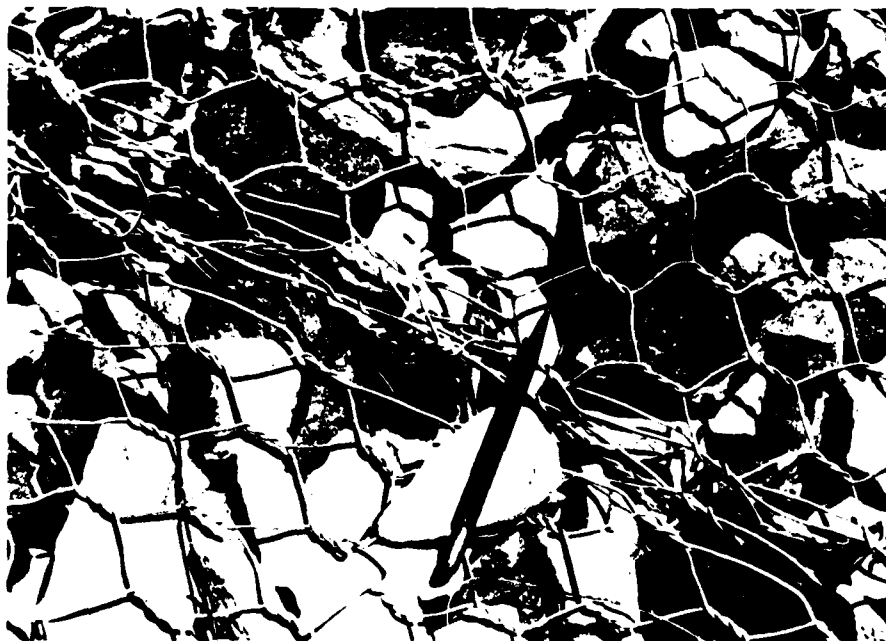
Figure 16. Detail view of rock and wire mattress where two gabions have been wired together (Section D)

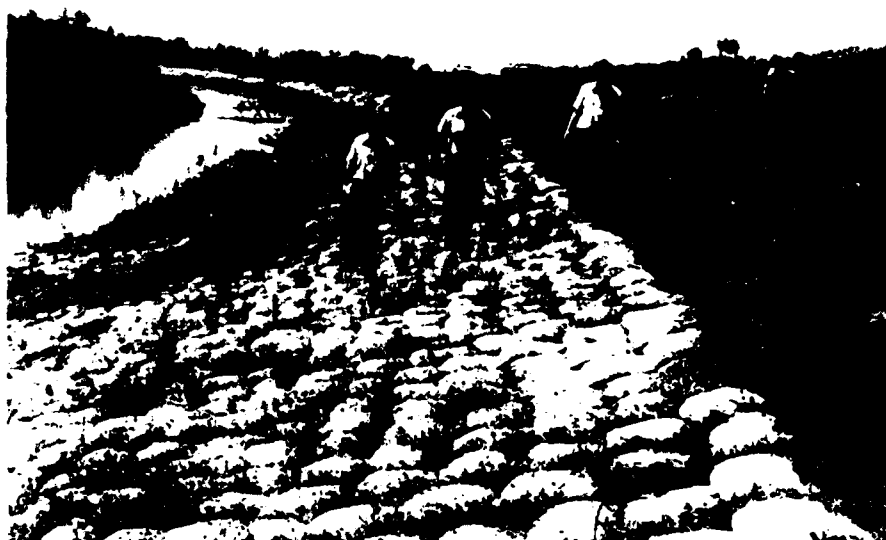
Figure 19. Upstream view of sand-filled acrylic bag test section (Section E). Disposed material removed from the toe trench is located in the extreme left portion of photograph
